#### Bioretention Dispelling the Myths

#### Mark Liebman

Sustainability Workshop Ltd Acknowledge STORM Consulting, Kiama Council & Allison Dunphy

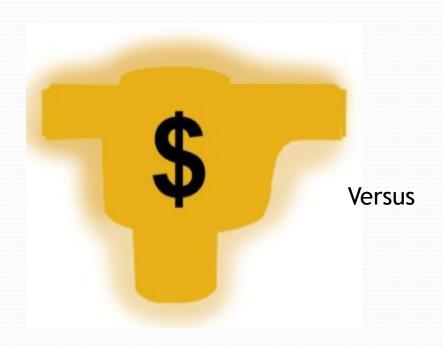
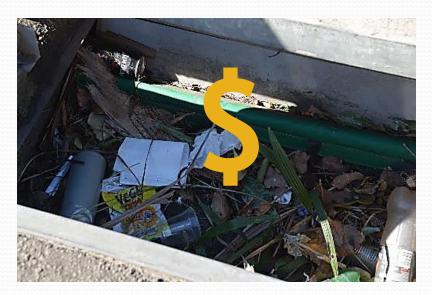
# Gross Pollutant Mgmt

- Council happy with outcome
- Early 200 micron bags → 1600 micron bags
- Maintained by hand lighter easier maintenance
- Early on cigarettes and fireworks burnt some bags
- Both Enviropod and Ecosol RSF100s in place and both perform well
- Maintenance guys winge
- CDS unit better??

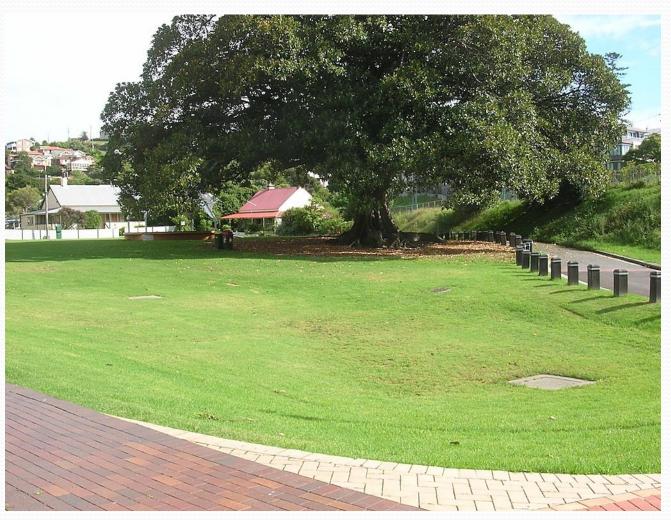
- Sand filter or bioretention system?
- Plastic lined
- Coarse river sand
- Non woven geofabric

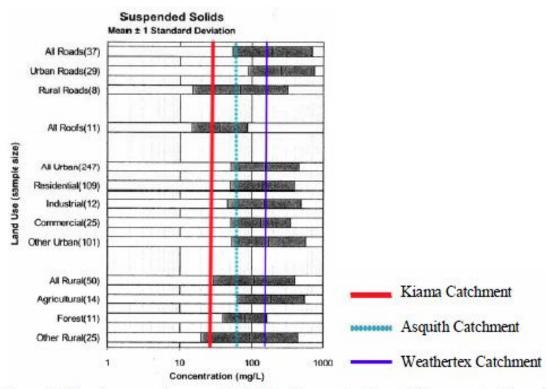
Figure 5-21 – Average Suspended Solids Concentration of Stormwater from the Current Study Catchments Compared With Other Studies (adapted from Duncan, 2005)

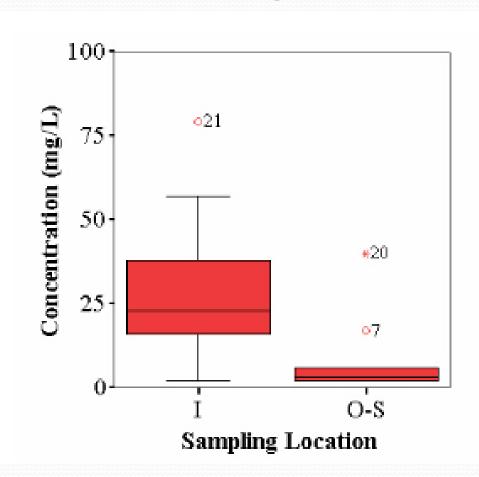
- TSS ↓ 75%
- Starting TSS affected by litter baskets
- Including baskets + filter – total TSS reduction would exceed 85%

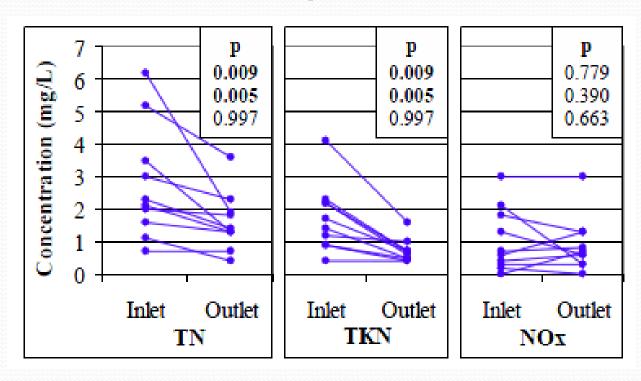
- 40% TN ↓
- 70% is TKN
- 30% NOx
- 55% TKN removed
- 11% ↑ NOx

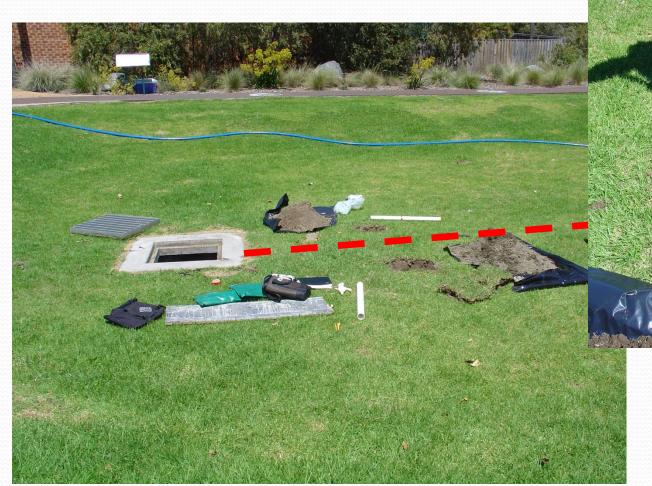
2005 Investigation

- Filter inspected in Nov 2005 & July 2014
- 2005 investigation:
  - Triggered by no outflow during sampling
  - Excavated test hole to geofabric layer
  - Used hydrant (3l/s) to wet filter to saturation & o/flow
  - Tested porosity of geofabric
  - Reuse system not yet operational
- 2014 Investigation:
  - Excavated test hole to geofabric
  - Collected samples testing of PSD by UTS planned

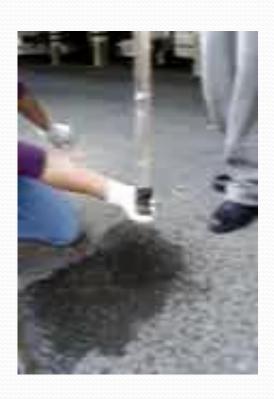
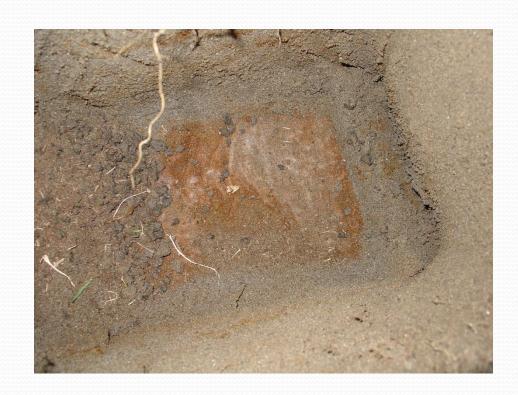
## Porosity of geofabric

- Geofabric not at all blocked despite biofilm growth
- During spring rooting depth of grass was down to bottom of media surrounding HydroCon pipe and significant (density) elsewhere.
- Some caking of fines on pipe wall
- Use of hydrant peak flow of 3 L/s easily accommodated in pipes without surcharge - beyond this not sure of capacity.
- Water ponded in base of filter together with prolonged delay to the onset of outflow indicated unplanned reservoirs formed in the base of the filter.

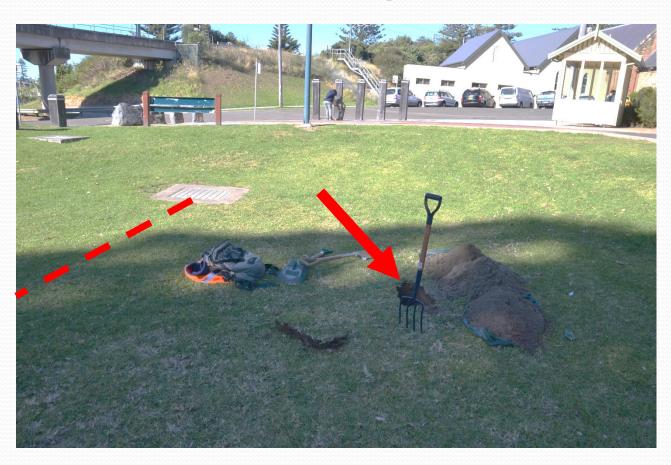
# 2014 Investigation

- Despite poor maintenance bioretention system in excellent condition
- Working to trap significant quantities of sediment
- Can't comment on other parameters
- Filter media & geofabric remains highly permeable
  - harvesting water routinely in summer must be working no need to test.
- Unfortunately Council not tested or metred harvested water.
- Council very happy with system
